## II: THE WILLIAM ELLIOT AND ANDREW JACKSON WILLIAMS HOUSES: HISTORIC THEMES

### Architecture, Engineering & Decorative Arts

#### William Elliot House

#### Andrew Jackson Williams House

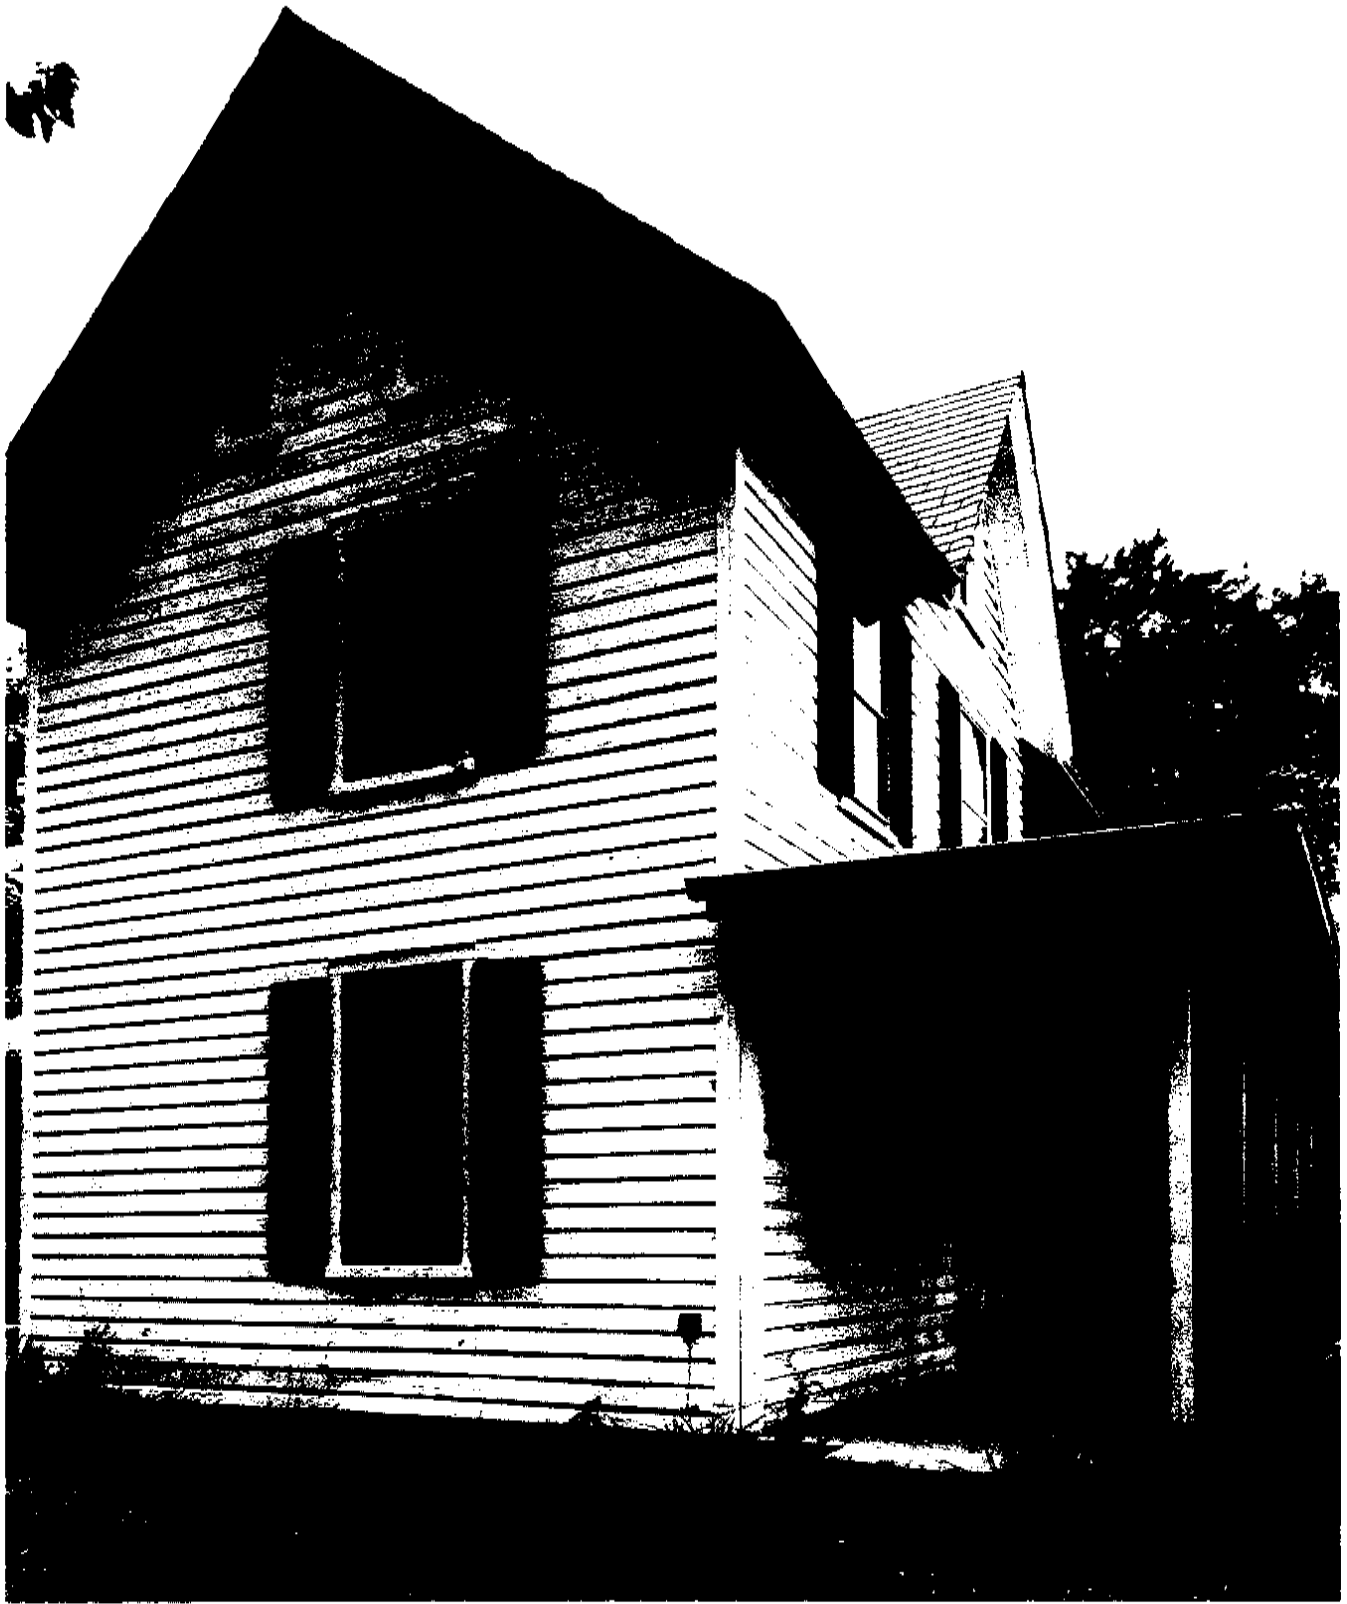
Probably built in the 1870s, the dwelling is a three-bay, two-and-one-half-story, gable-roofed, frame structure with a center gable. A two-bay,

PLATE 1: The William Elliot House (Photograph by David L. Ames, 1987)

The William Elliot House (Plate 1) is located at 2206 Newport Gap Pike, Wilmington, Delaware, on roughly 1.5 acres on the south side of Newport Gap Pike (State Route 41), approximately 0.3 miles west of its intersection with Kirkwood Highway (State Route 2). Situated on the floodplain of the Red Clay Creek, approximately 200 feet east of the creek, the dwelling is surrounded by mature trees with a large open lawn to the south. A hedge shields the house along its 172-foot frontage with Newport Gap Pike. At the time of this examination, the structures' architectural character remained intact. Subsequent vandalism has stripped the building of all original fabric.

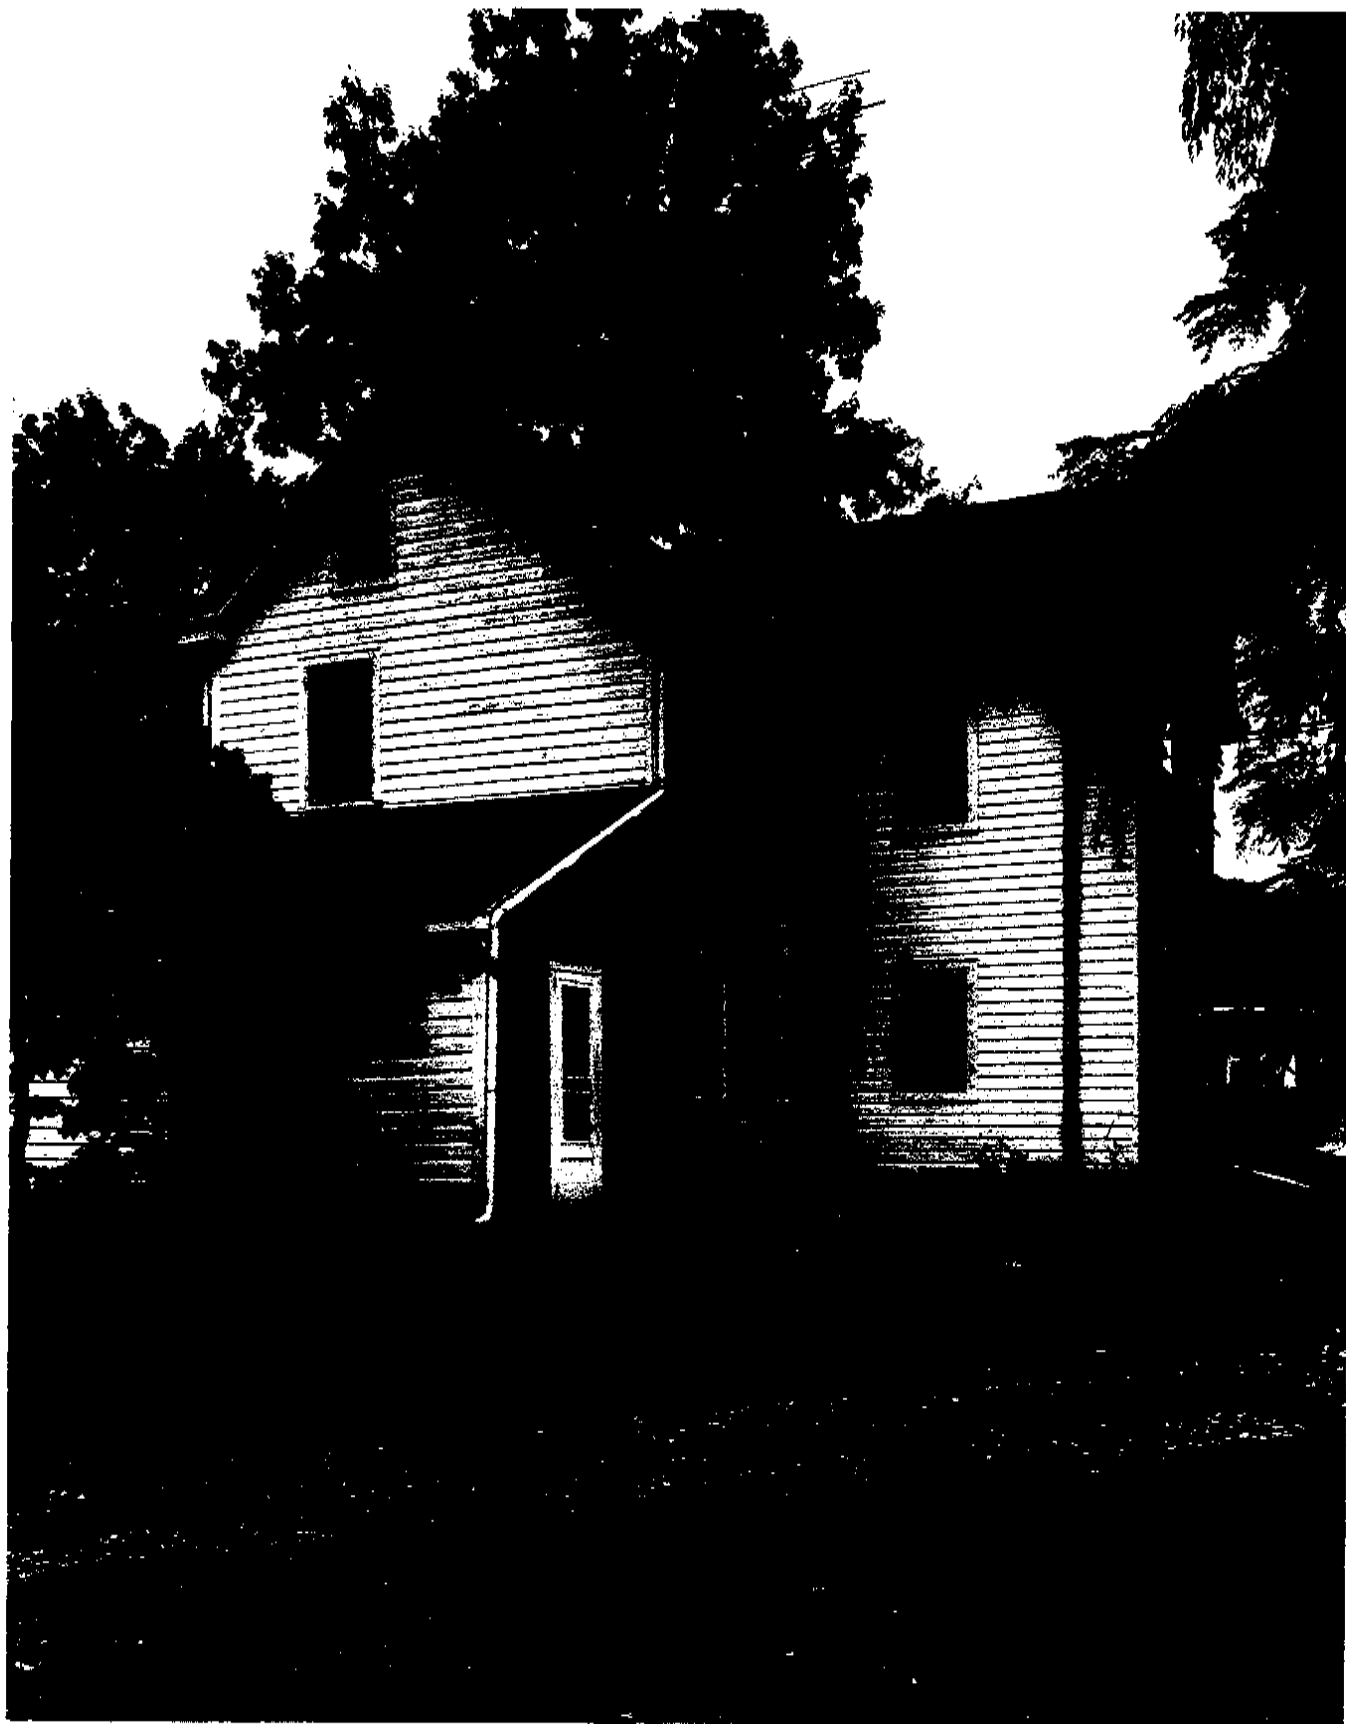
PLATE 4: Rear View of the Williams House  
(Photograph by David L. Ames, 1987)

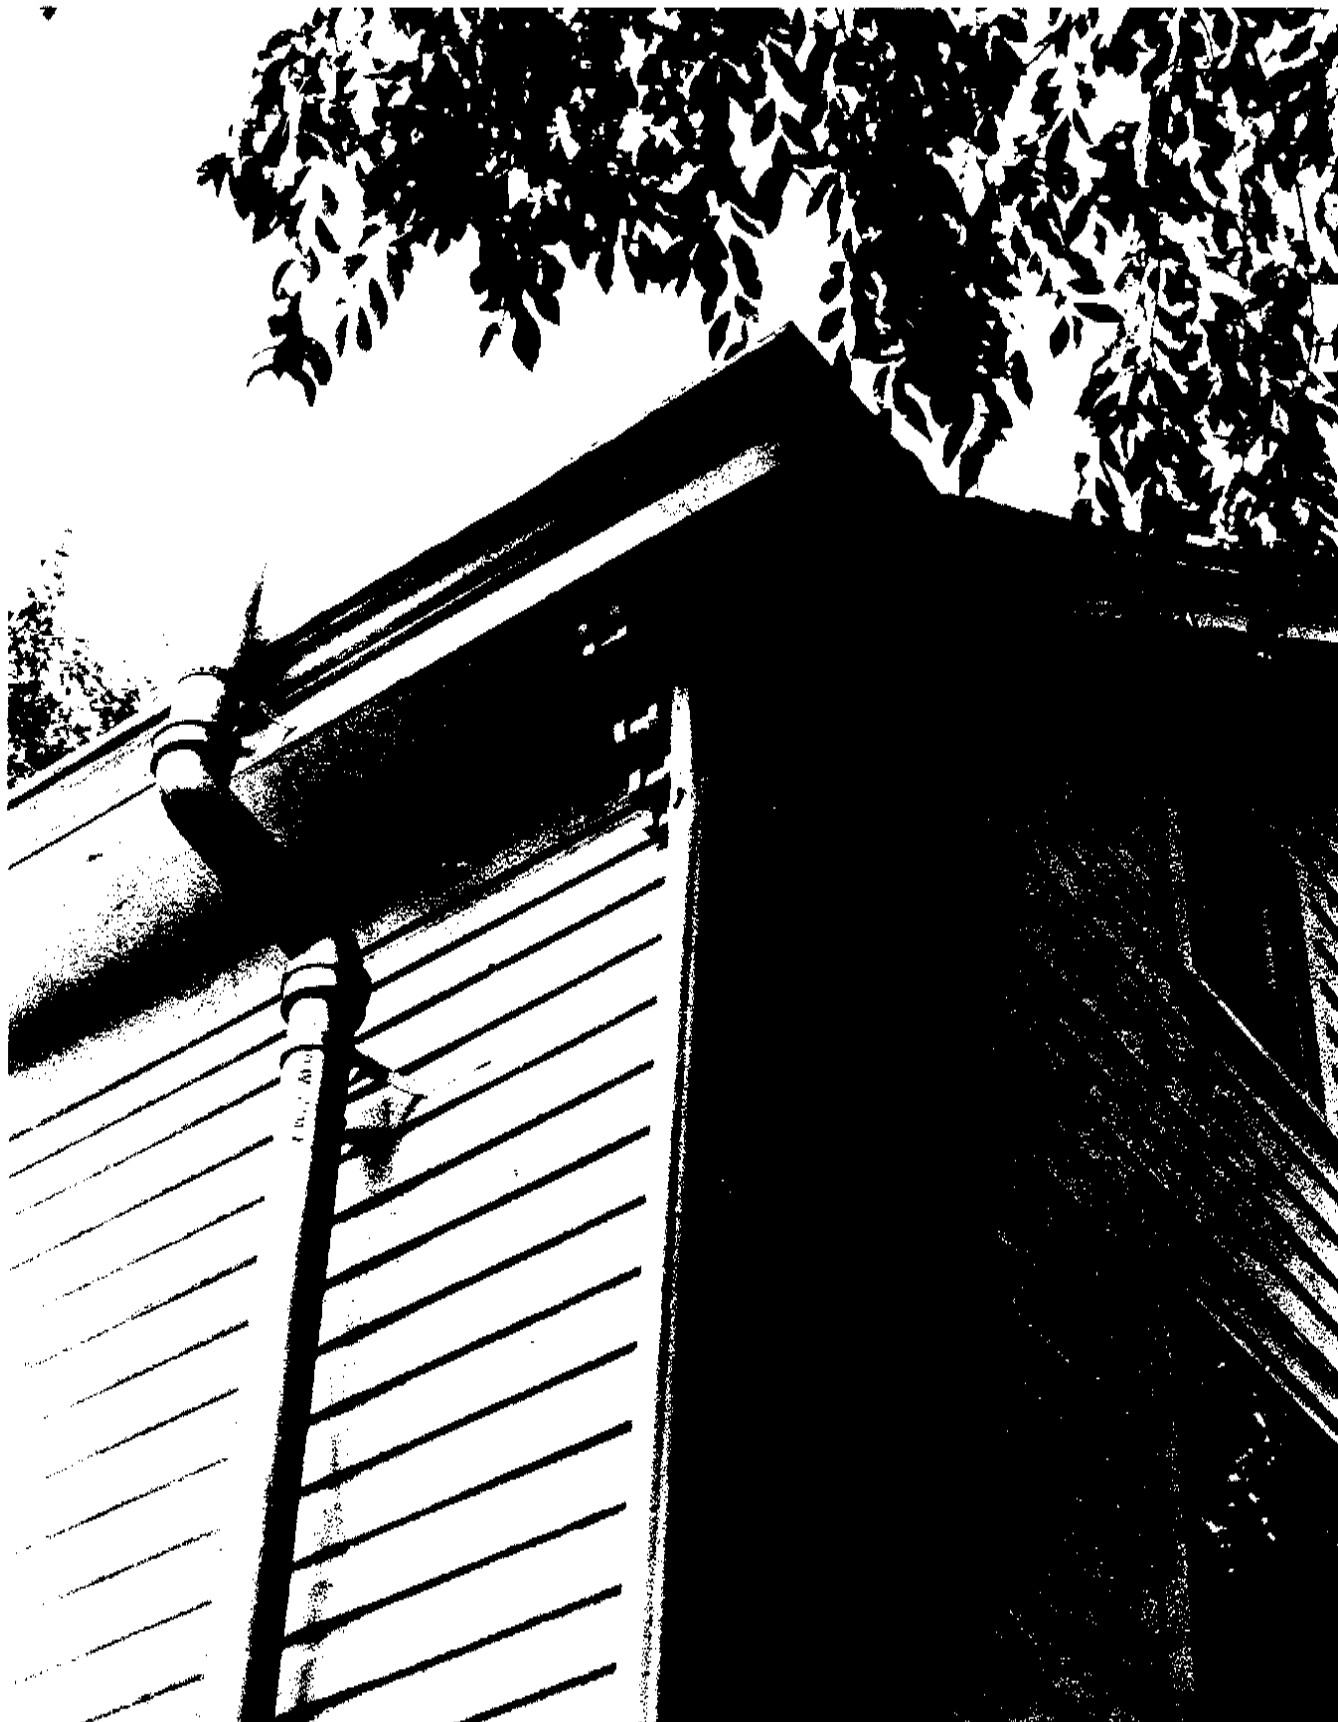
Both the Elliot House and the Williams House functioned as dwellings during the period of their significance. The historic theme Architecture, Engineering, & Decorative Arts normally would be most descriptive of the historic patterns associated with the Elliot and Williams houses. Ornamental motifs from three architectural styles popular in the mid-nineteenth century -- Greek Revival, Gothic Revival, and Italianate -- are exhibited in the two buildings and would tend to support this view. Borrowing classical Greek motifs, Greek Revival structures were often ornamented with pedimented and/or colonnaded porches, elaborated entrances and surrounds, frieze boards and box cornices. Gothic Revival buildings exhibited center-gable facades, pointed arch windows and projecting cornices. Italianate structures displayed large eave brackets and partial returns on their gable ends. The Elliot House possesses a center-gable facade penetrated with a pointed arch window in the attic and projecting cornices reminiscent of Gothic Revival. The Elliot house simultaneously possesses a colonnaded porch often found on Greek Revival structures. The Williams House juxtaposes frieze boards and box cornices normally found on Greek Revival structures with eave brackets and partial return gable ends imitative of Italianate buildings (Plate 5).<sup>6</sup>

PLATE 5: Detail of the brackets on the Williams House (Photograph by David C. Bachman, 1985. Reprinted with the permission of DELDOT)
